# State of Aurora Lake 2024

## Water Quality Assessment and Management Plan

Report Prepared By:  
Edward Kwietniewski  
**AQUA DOC Lake & Pond  
Management Inc.**

**Project:** State of the Lake Report and Management Plan

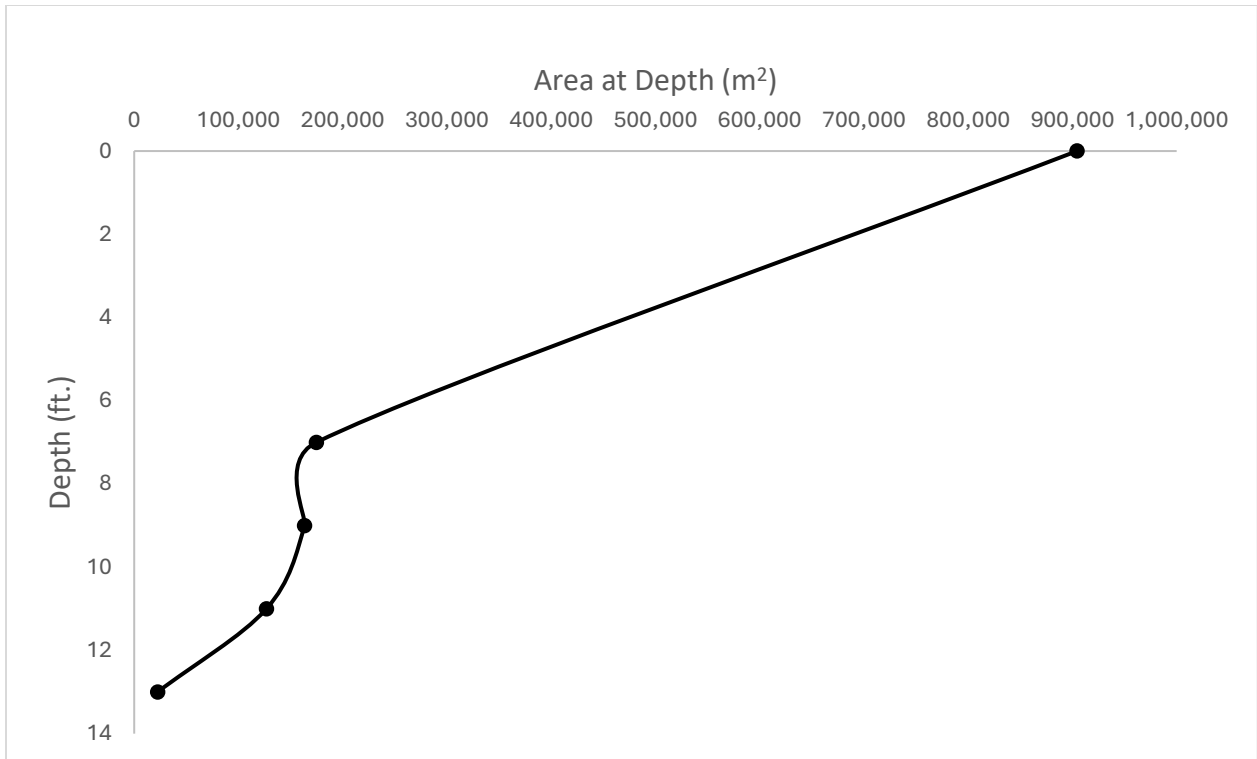
Figure 1: Conceptual hypsography of Aurora Lake's depth loosely based off the bathymetric map generated by EnviroScience (EnviroScience 2020).

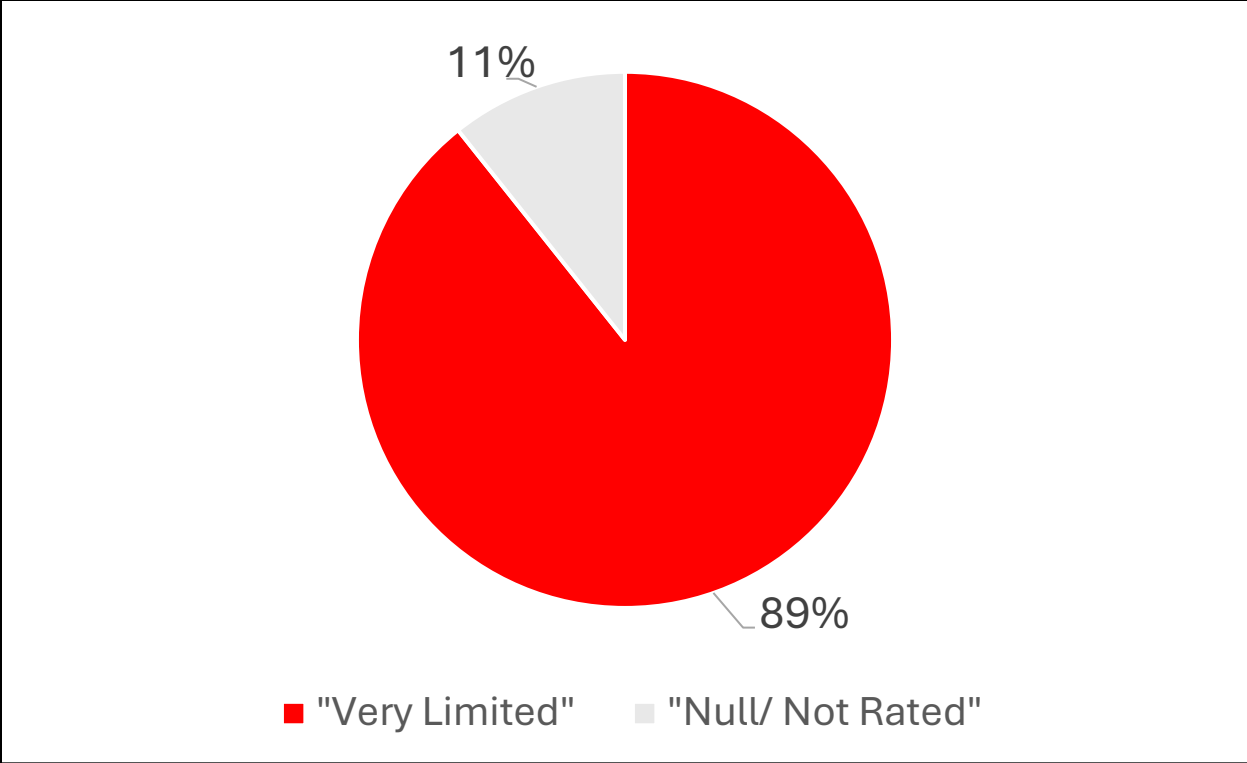
Figure 8: Soil suitability for septic systems in the Aurora Lake watershed (USDA 2022).

Soils within the Aurora Lake watershed are noted to be poorly suited for septic system usage as 89% of the watershed is considered “very limited” for septic functioning and the remainder of the watershed rating was unattainable or not rated (Figures 7 and 8).

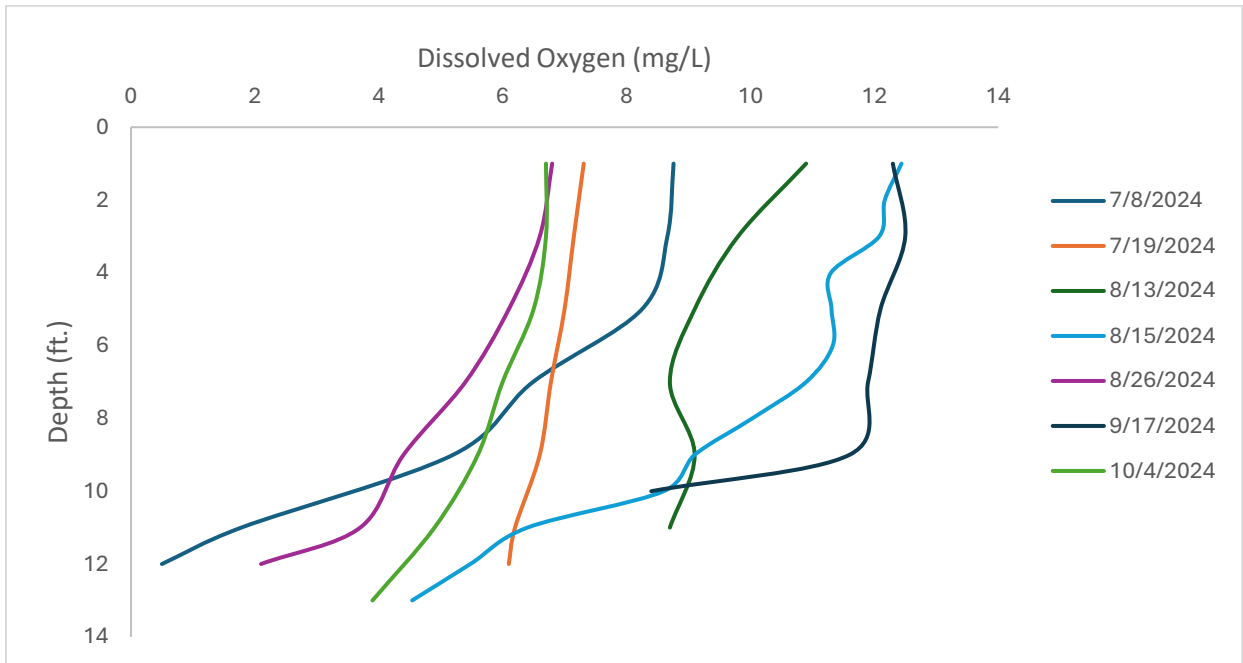
*Dissolved oxygen* – DO concentrations were widely variable throughout the 2024 sampling period but generally showcased a pattern of reduction as deeper depths are reached (Figure 11). Benthic as well as surface DO concentrations showcased variability. Maximum DO concentration was observed to be 12.5 mg/L at 3.0 ft of depth on 9/17/2024. Minimum DO was 0.5 mg/L found at the very bottom of the reservoir on 7/8/2024. DO concentrations never reached 0.0 mg/L during any sampling event.

Figure 11: DO depth profiles at the deep point of Aurora Lake from 7/8/2024 to 10/4/2024.

Dissolved oxygen (DO) concentrations did not follow the same, mixed pattern as the noted temperature profiles (Figure 11). All DO profiles from 7/8/2024 to 10/4/2024 showcased a general trend of reduction as depth increased to varying degrees. However, DO concentrations did not reach the point of anoxia (0.0 mg/L of DO). Hypoxia (low DO) was noted at the bottom of the lake on 7/8/2024 and 8/26/2024 (0.5 mg/L and 2.1 mg/L at bottom for 7/8 and 8/26 respectively). The highest noted concentration of DO did coincide with a notable bump in chlorophyll  $\alpha$  (Figures 11 and 22) suggesting elevated photosynthetic activity from algal biomass may explain the overall increase in DO during that sampling event. This same sampling event also showcased the greatest DO change at depth (9/17/2024, 11.6 mg/L to 8.4 mg/L at 9 – 10') likely due to decomposing algal biomass below the photic zone. Sampling on this date did not proceed to 13.0 ft like on other sampling days and it is hypothesized that a substantial further reduction in DO would have been observed if sampled. Future DO profile data collection should be collected at the deepest known point of the lake to ensure benthic anoxia can be identified if present particularly if redox reactions are of concern. Anoxic conditions in lakes and reservoirs are important to consider as phosphorus (P) can be released from the sediment layer of the lake itself as iron as the ion  $\text{Fe}^{3+}$  is reduced to the ion  $\text{Fe}^{2+}$ . When iron is in the  $\text{Fe}^{3+}$  form, it will readily bind to phosphorus and make it biologically unavailable for utilization by algae and submersed plants. However, when in the  $\text{Fe}^{2+}$  form, there is a greater chemical affinity for sulfur (S) in the form of the ion  $\text{S}^{2-}$  and will release P it may have been previously bound to. Since iron is no longer binding to P, it can become released into the water column. Typically, this results in a build-up within the hypolimnion of lakes and reservoirs

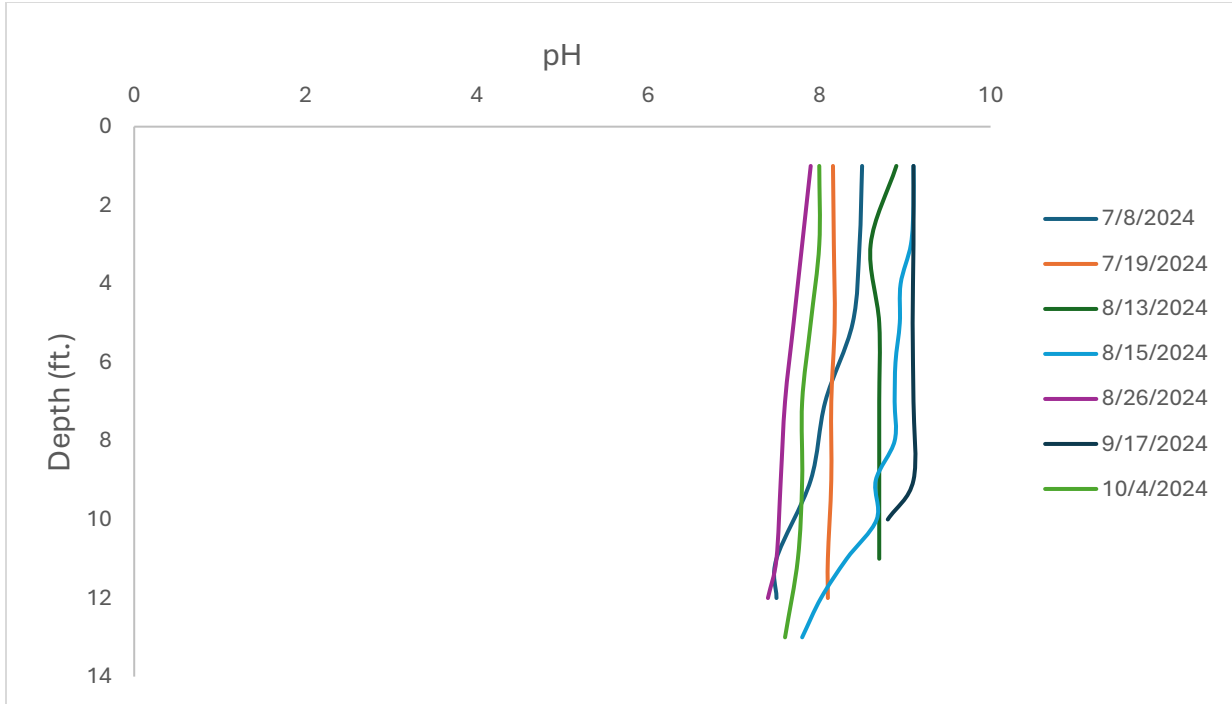
*pH* – The pH of Aurora Lake stayed within acceptable levels for gilled aquatic organisms (Figure 12; above 5.3 and below 11). The highest pH value recorded was found to be 9.1 observed multiple times 8/15/2024 and 9/17/2024. The lowest pH value was found to be 7.4 at the bottom of the lake during the 8/26/2024 sampling event.

Figure 12: pH depth profiles of Aurora Lake at the deep point from 7/8/2024 to 9/17/2024.

pH values found during the 2024 season mimicked mixed conditions showcased by the temperature data and stayed well within acceptable levels for aquatic organism survival (Figure 12). All collected data points showcased near neutral to alkaline conditions during the 2024 lake season (between 7.4 – 9.1). pH values below 6.5 may begin to show detrimental impacts on aquatic biota (Campbel and Stokes 1985) while acidic values (occasionally noted below 5.3) may alter aluminum ions in water bodies to a form that can harm gills. Very high alkaline values can also have a negative impact on aquatic biota, but pH extremes are rare for a typical Ohio water body. Slight fluctuations in pH are common in water bodies as they are dynamic entities. Increasing photosynthetic activity is one way that pH can naturally rise in water bodies that should be noted in this report. Calcium carbonate (a component of alkalinity and impacts pH) production increases as a product of photosynthetic activity, driving increasing pH levels. With noted algal blooms being more frequently noticed on Aurora Lake, it is possible that pH fluctuations can occur more frequently during bloom “boom and bust” cycles. Although not noted as an issue for the 2024 season, in-situ sampling within bloom events would confirm this for the future and give insight into whether pH fluctuations could become an issue for aquatic biota.

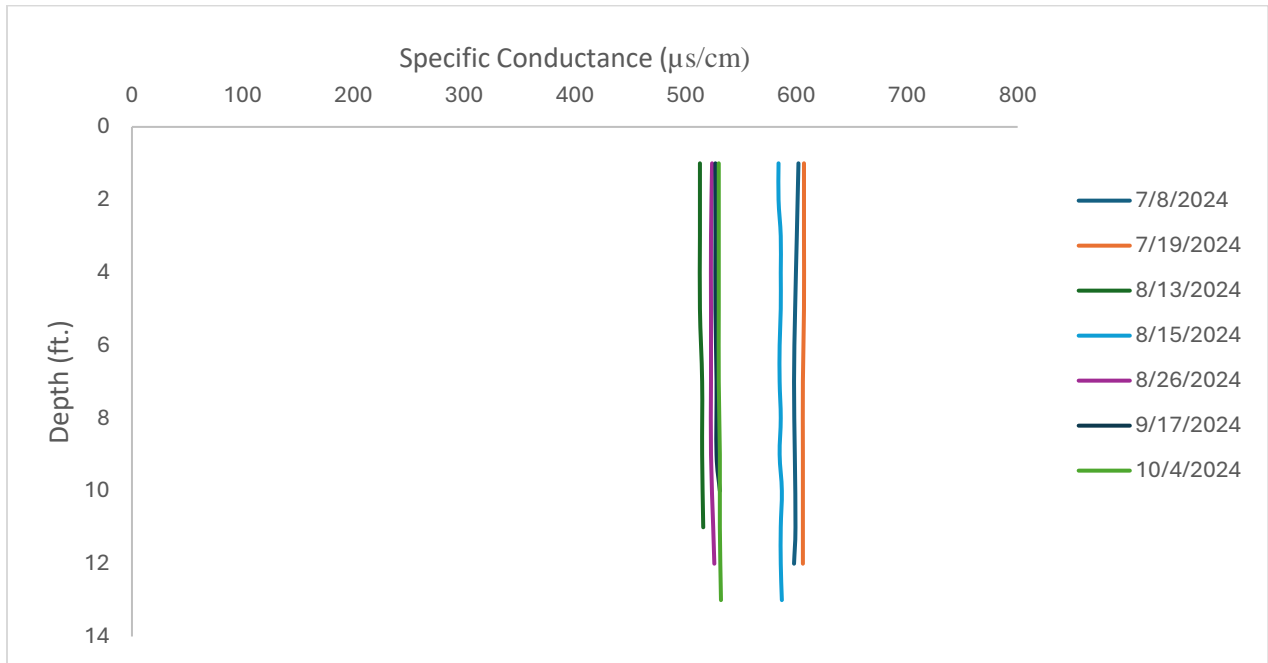
*Specific conductivity* – Specific conductivity remained consistent throughout all sampling dates. The highest observed value was found to be 607  $\mu\text{s}/\text{cm}$  on 7/19/2024. The lowest was found to be 513  $\mu\text{s}/\text{cm}$  on 8/13/2024. Specific conductance trends within the water column are shown in Figure 13.

Figure 13: Specific conductance depth profiles of Aurora Lake at the deep point from 7/8/2024 to 9/17/2024.

Observed conductivity values did not showcase any indication that Aurora Lake is impacted by excessive ion introduction via pollutant discharge into the system (e.g. road salt introduction from the watershed; Figure 13). For some water bodies, aggressive salt usage or

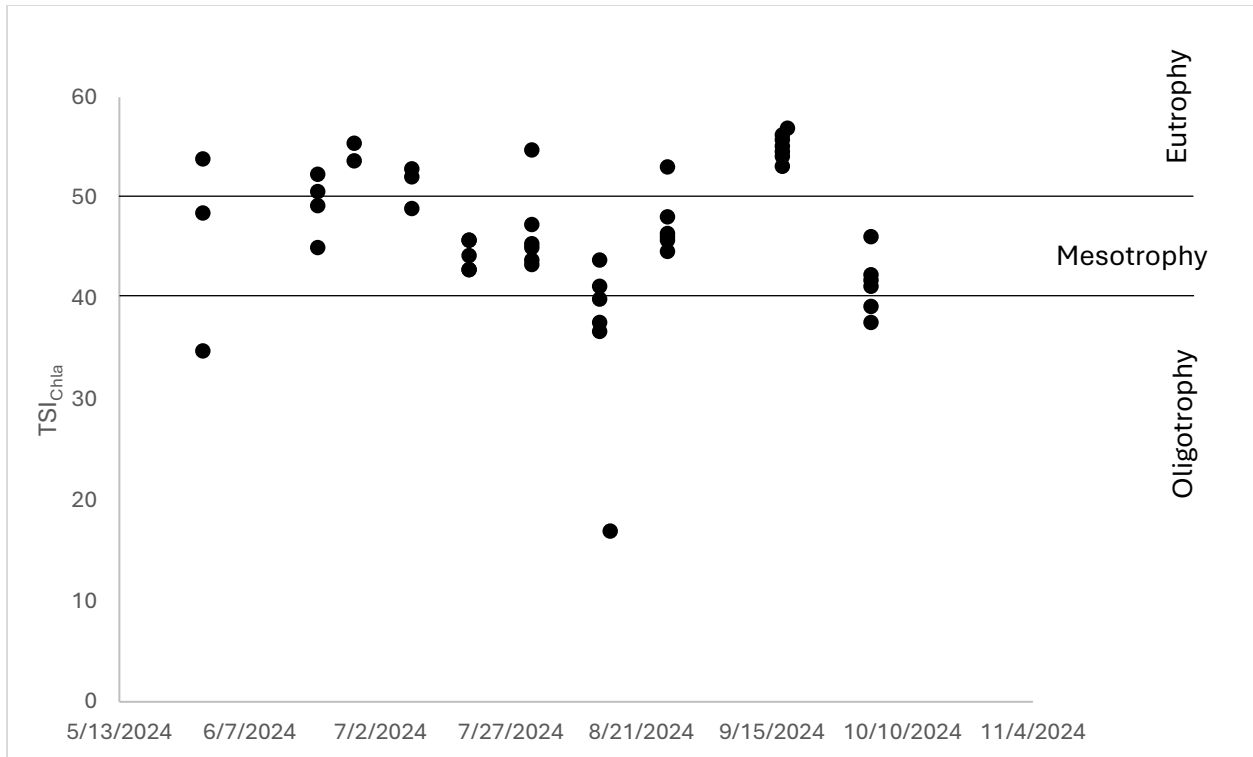
Figure 15: Carlson's TSI<sub>Chl α</sub> values (n = 48) for Aurora Lake from in-situ surface chlorophyll α data collected through the 2024 lake season. Different estimated trophic designations are identified on the right of the graph.

*Carlsons’s TSI (Trophic State)* – The trophic state of Aurora Lake based off spatial surface in-situ chlorophyll  $\alpha$  data throughout the 2024 season and Carlson’s TSI (Carlson 1977;  $TSI_{Chl\ \alpha}$ ) straddles between being categorized as mesotrophic (middling productivity) and eutrophic (high productivity; Figure 15).  $TSI_{TP}$  from data collected in 2018 and 2024 firmly suggests Aurora Lake is eutrophic for both years (Figure 16). The single Secchi transparency reading from 8/15/2024 also suggests eutrophy ( $n = 1$ ,  $SD = 1.25$  ft,  $TSI_{SD} = 73.92$ ).  $TSI_{Chl\ \alpha}$  had the greatest sample size ( $n = 48$ ) and showcased a moderate degree of variability throughout the lake season (May – October). The highest  $TSI_{Chl\ \alpha}$  value was 56.94 at the Kovach boat slip on 9/18/2024, lowest  $TSI_{Chl\ \alpha}$  was 16.94 at the deep point of the lake on 8/15/2024, and the mean  $TSI_{Chl\ \alpha}$  for all sampled locations throughout 2024 was 46.55. The highest  $TSI_{TP}$  value amongst all available TP data between 2018 and 2024 was 82.6 on 8/17/2018, lowest  $TSI_{TP}$  value was 65.44 at the middle of the lake on 7/3/2024, mean  $TSI_{TP}$  for all 2024 collected data was 68.44 (this mean does not include 2018). All TSI values are highlighted in Appendix E below.

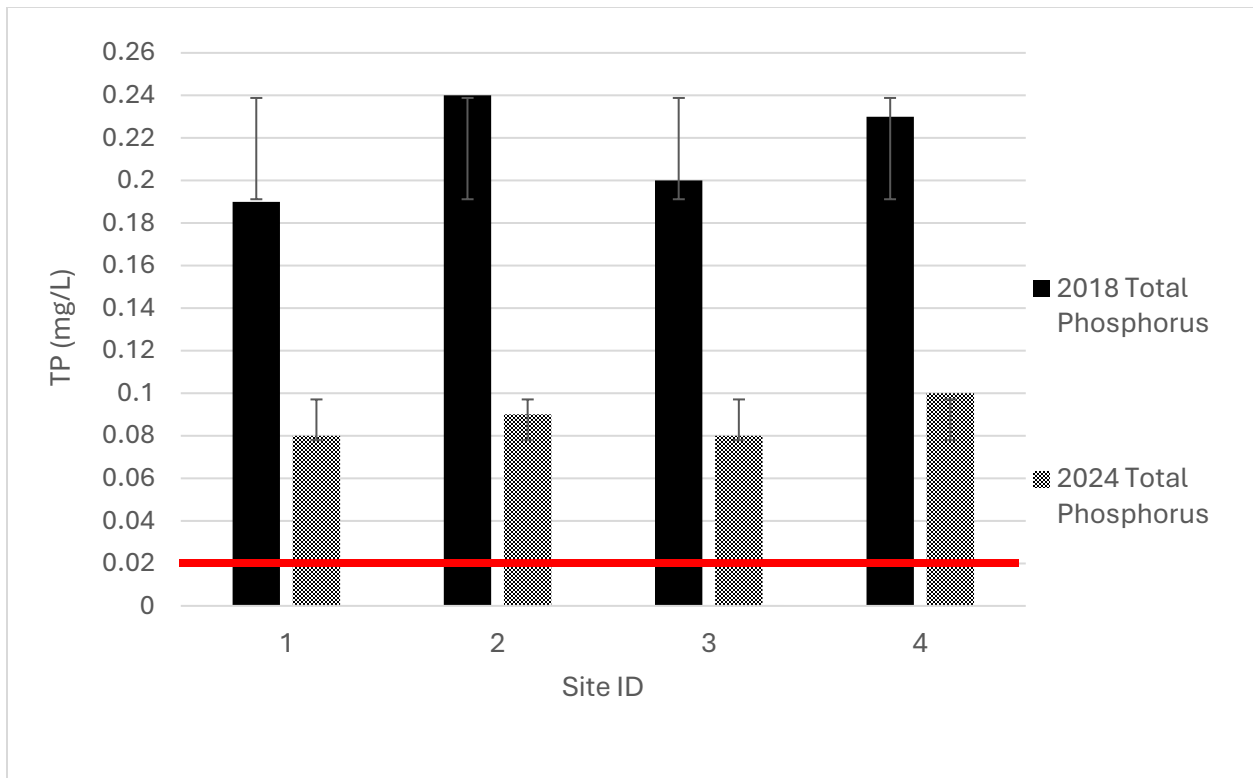
Figure 17: Visual comparison of total phosphorus concentrations reported in the 2018 EnviroScience survey (solid black) and what was collected during the 2024 survey (checkered black). Red line denotes 0.02 mg/L threshold commonly used to separate eutrophic conditions from mesotrophic. Error bars represent 1 standard deviation from the mean for each data set (stdev 2018 = 0.024, stdev 2024 = 0.009). Site identifiers: site 1: deep point surface sample, site 2: deep point bottom sample, site 3: NW Inlet near marina, site 4: S inlet at end of Sweet Grass Cir.

*Water column nutrient data* – TP levels noted from Aurora Lake ranged between 0.08 – 0.1 mg/L (80 – 100 µg/L; Table 2) during the 2024 sampling date. These values showcased a noticeable reduction on water column TP at comparable sampling locations from the 2018 survey (EnviroScience 2019; Table 3). Highest TP value noted (0.1 mg/L or 100 µg/L) was identified at two sites (sites 2 and 8).

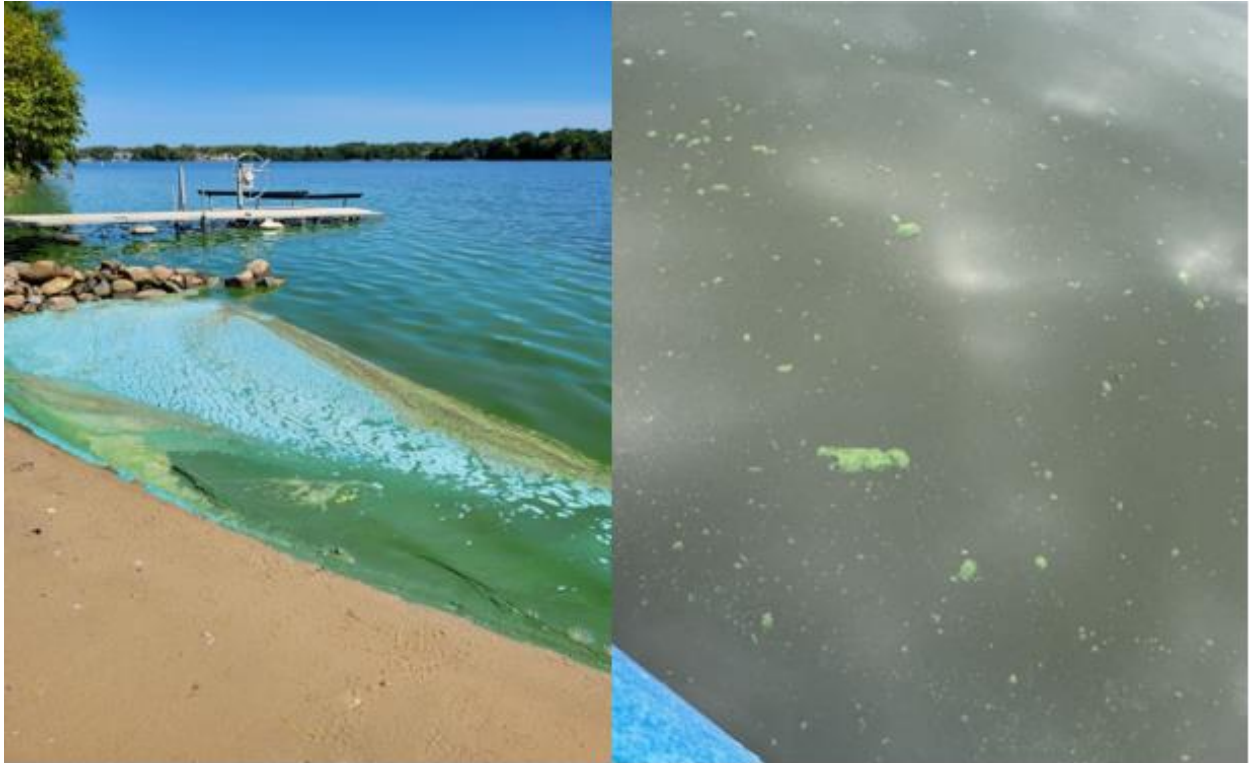
Figures 19 and 20: Images of planktonic algae growth taken during the 2024 season. Left photo of cyanobacteria during September credit: Dawn Holeman. Right photo of planktonic algae growth in middle of lake during June credit: Joe Kovach.

**Figures 19 and 20:** Images of planktonic algae growth taken during the 2024 season. Left photo of cyanobacteria during September credit: Dawn Holeman. Right photo of planktonic algae growth in middle of lake during June credit: Joe Kovach.

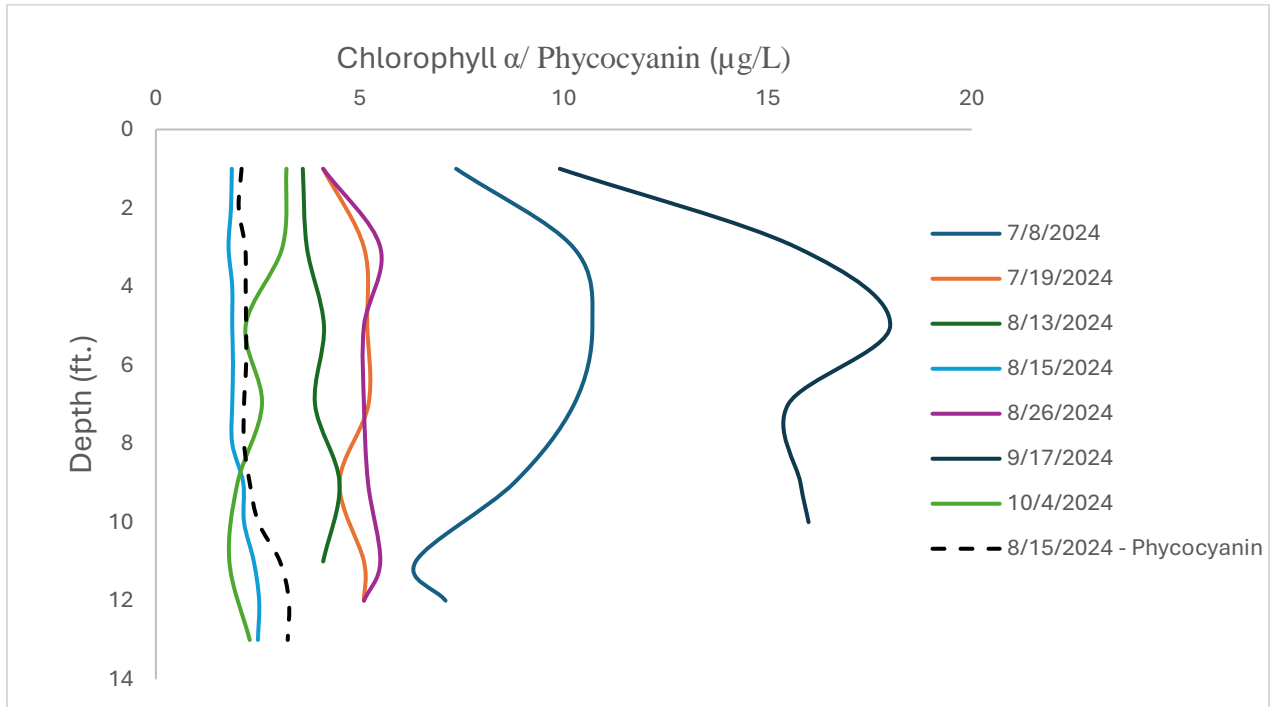
*Chlorophyll α/phycoerythrin* – Chlorophyll α (Chl α) concentrations were variable throughout the 2024 sampling period but appeared to denote a bloom-like increases on 7/8/2024 and 9/17/2024 (Figure 22). All other sampling dates showcased a relatively consistent concentration from surface to bottom. Maximum Chl α concentration was observed to be 18.0 µg/L at 5.0 ft of depth on 9/17/2024. Minimum Chl α concentration was 1.78 µg/L found at 3.0 ft. on 8/15/2024. Noted phycocyanin concentrations mimicked chlorophyll α trends on 8/15/2024 (dotted line) with a heightened value at the bottom (3.23 µg/L) likely from dead biomass.

Figure 22: Depth profile of chlorophyll α concentrations collected from 7/8/2024 to 10/4/2024 on Aurora Lake with phycocyanin concentrations noted on 8/15/2024 (dotted line). Data collected on 8/15/2024 was collected by AQUA DOC.

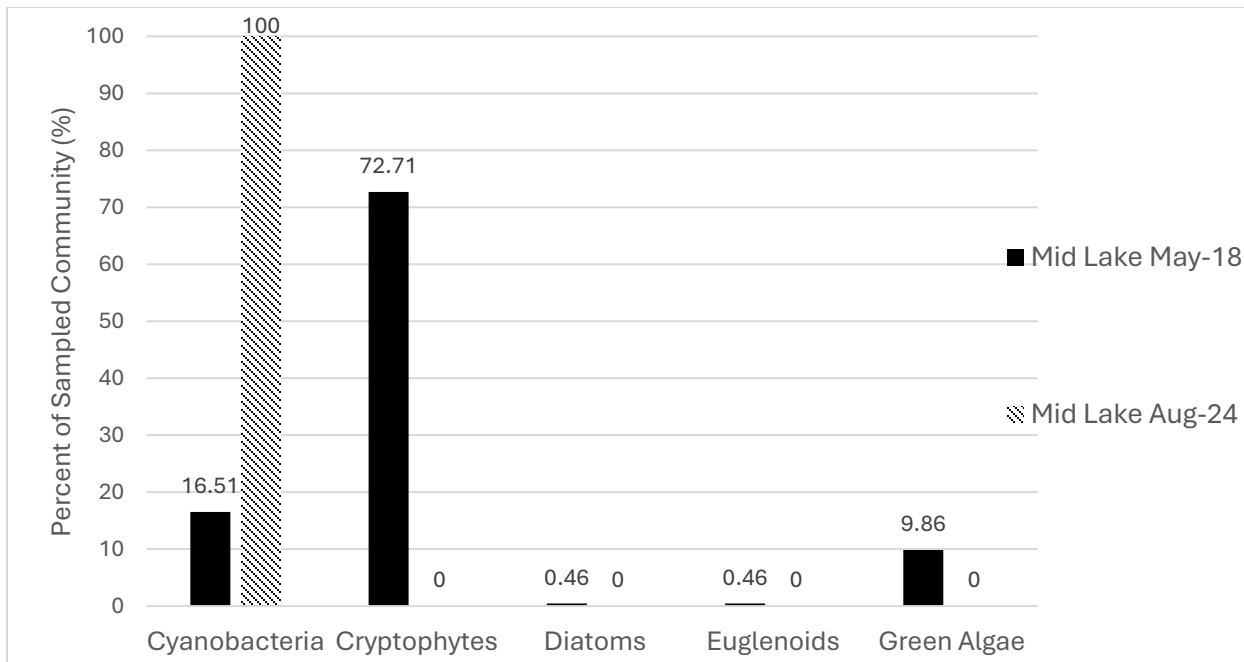
Figure 23: Percent of each algae taxon compared to the sampled community from Mid Lake in May of 2018 and Mid lake in August of 2024. 2018 data is from 2018 EnviroScience report (EnviroScience 2019).

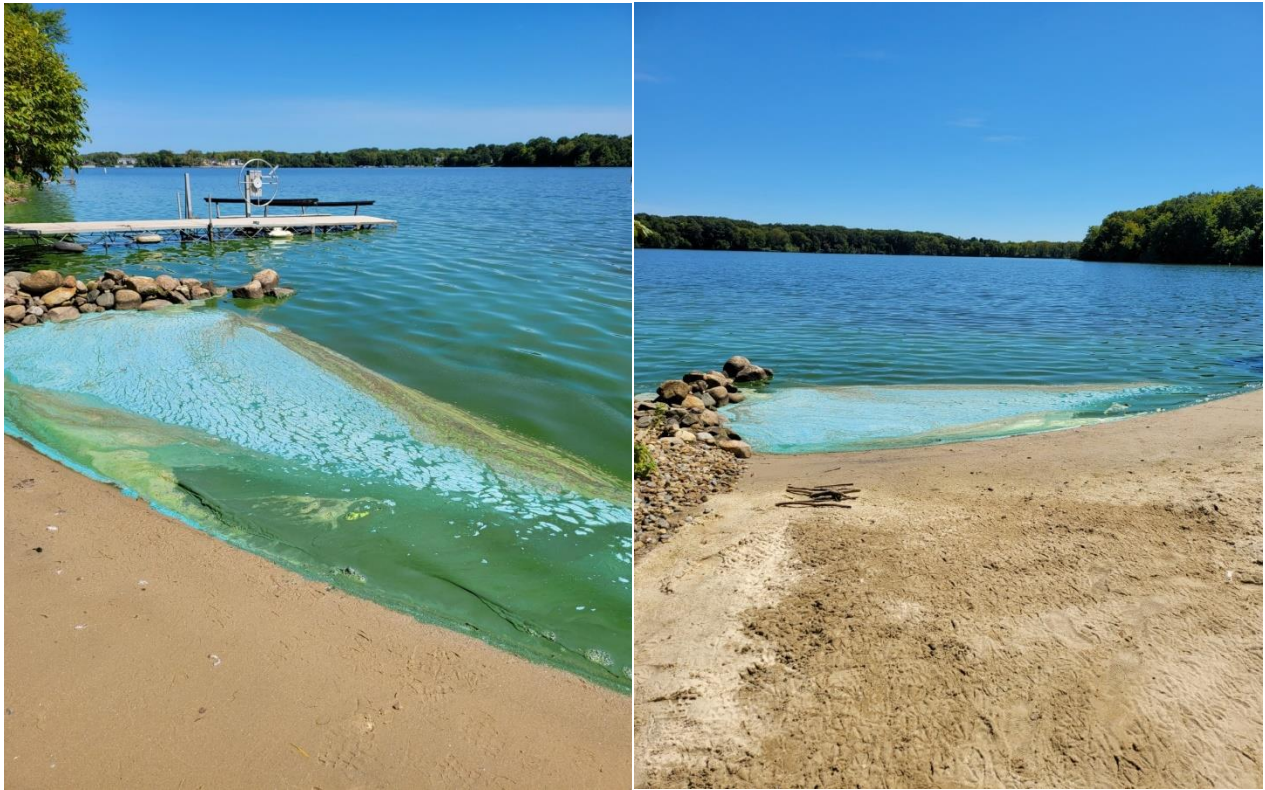
Figures 25 and 26: Heavy cyanobacteria growth noted in the cove of a residence shoreline in September of 2024. Image credit: Dawn Holeman.

**Figures 25 and 26:** Heavy cyanobacteria growth noted in the cove of a residence shoreline in September of 2024. Image credit: Dawn Holeman.

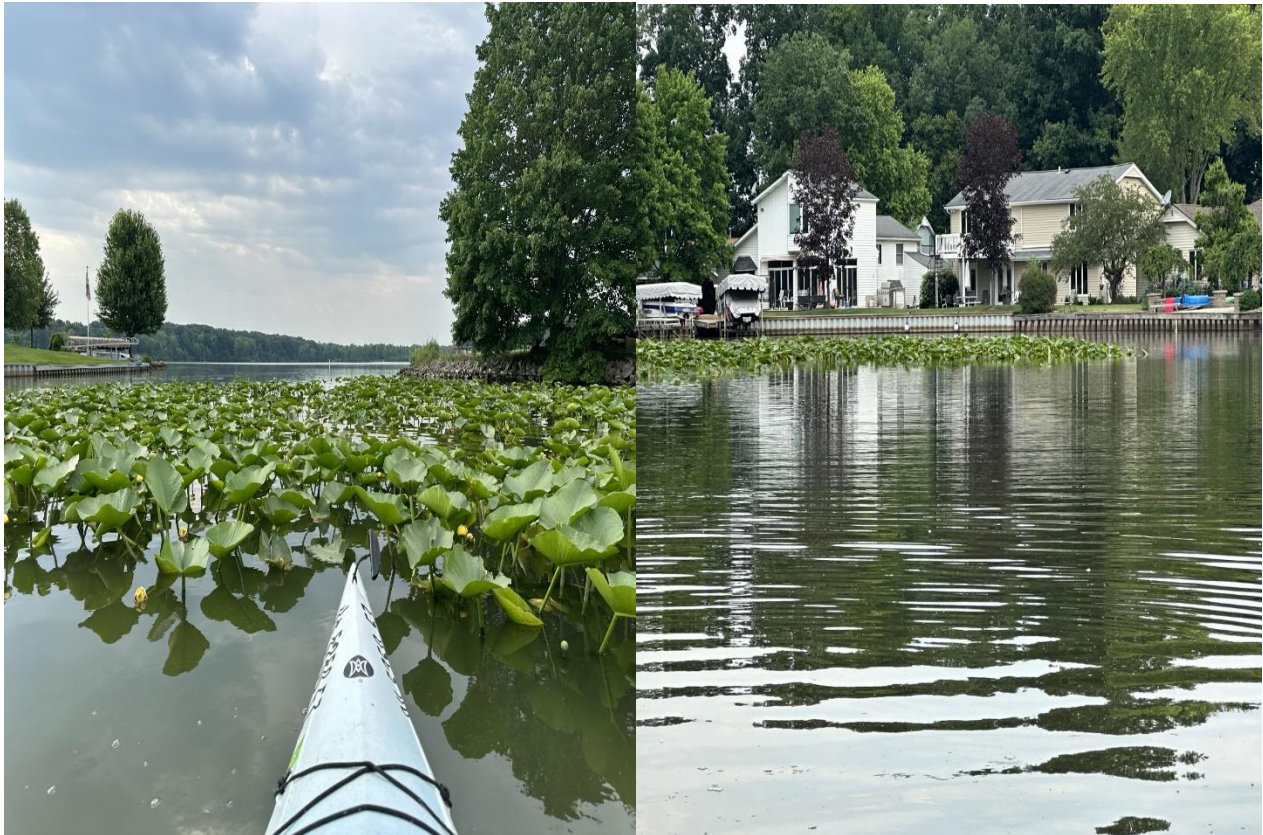
Figures 28 and 29: Images of spatterdock growth on Aurora Lake during the 2024 season. Image credit: Joe Kovach.

**Figure 28 and 29:** Images of spatterdock growth on Aurora Lake during the 2024 season. Image credit: Joe Kovach.

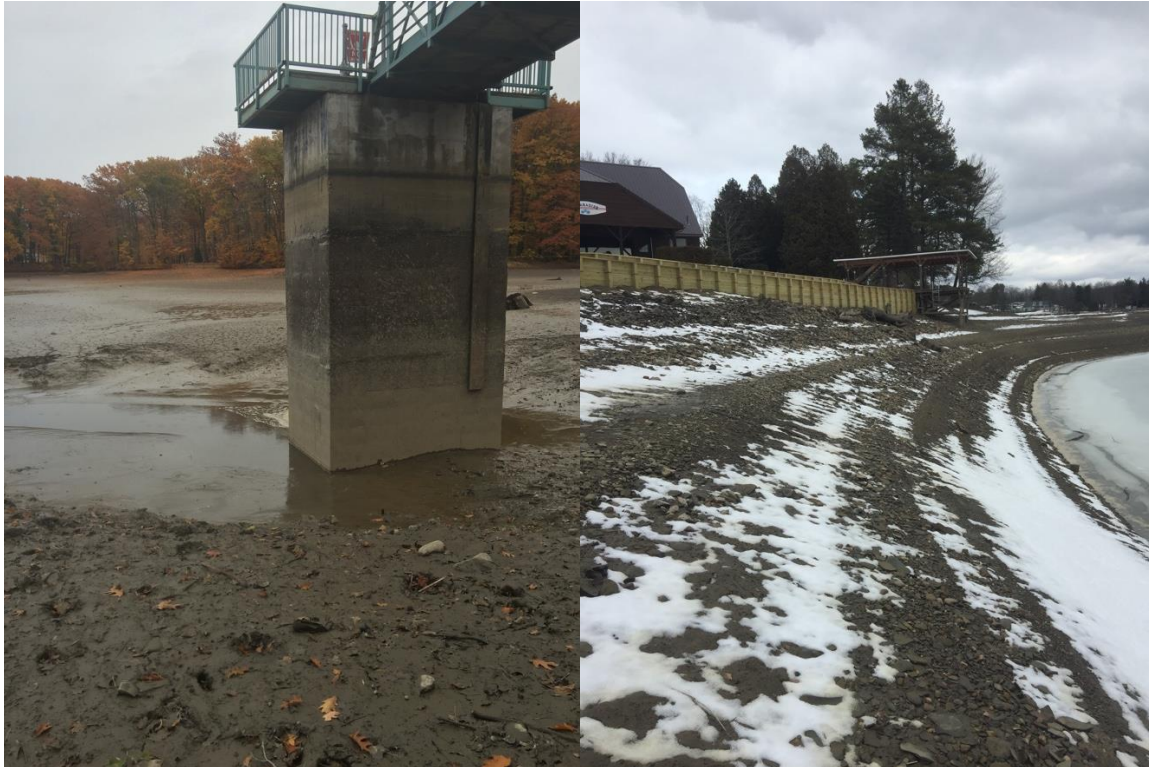
Figures 31 and 32: Image of a winter whole lake drawdown of Green Lake in Orchard Park, NY (left) and partial drawdown of Rushford Lake in Canadea, NY (right). Exposed benthic sediment and materials are showcased in both images. (Photos: Edward Kwietniewski)

**Figures 31 and 32:** Image of a winter whole lake drawdown of Green Lake in Orchard Park, NY (left) and partial drawdown of Rushford Lake in Canadea, NY (right). Exposed benthic sediment and materials are showcased in both images. (Photos: Edward Kwietniewski).

As highlighted previously, water level drawdown is more commonly associated with aquatic plant management than nutrient or algae reduction and the techniques impact on aquatic plants is more frequently documented. Although Aurora Lake is currently not experiencing issues with nuisance submersed aquatic vegetation growth, the addition of aquatic vegetation is a suggested management direction for the lake to investigate. Due to the

impact of water level drawdown on aquatic plant species, it would be wise to lower water levels with care as not to eliminate vegetation that may be planted as part of management strategies. Additionally, drawdown is selective to submersed plants whose reproductive structures and strategies can survive desiccation (Table 11; Carmignani and Roy 2021, Holdren et al. 2001). Therefore, when considering native aquatic plant additions to Aurora Lake, it may be beneficial to add varieties that are likely to return on an annual basis.

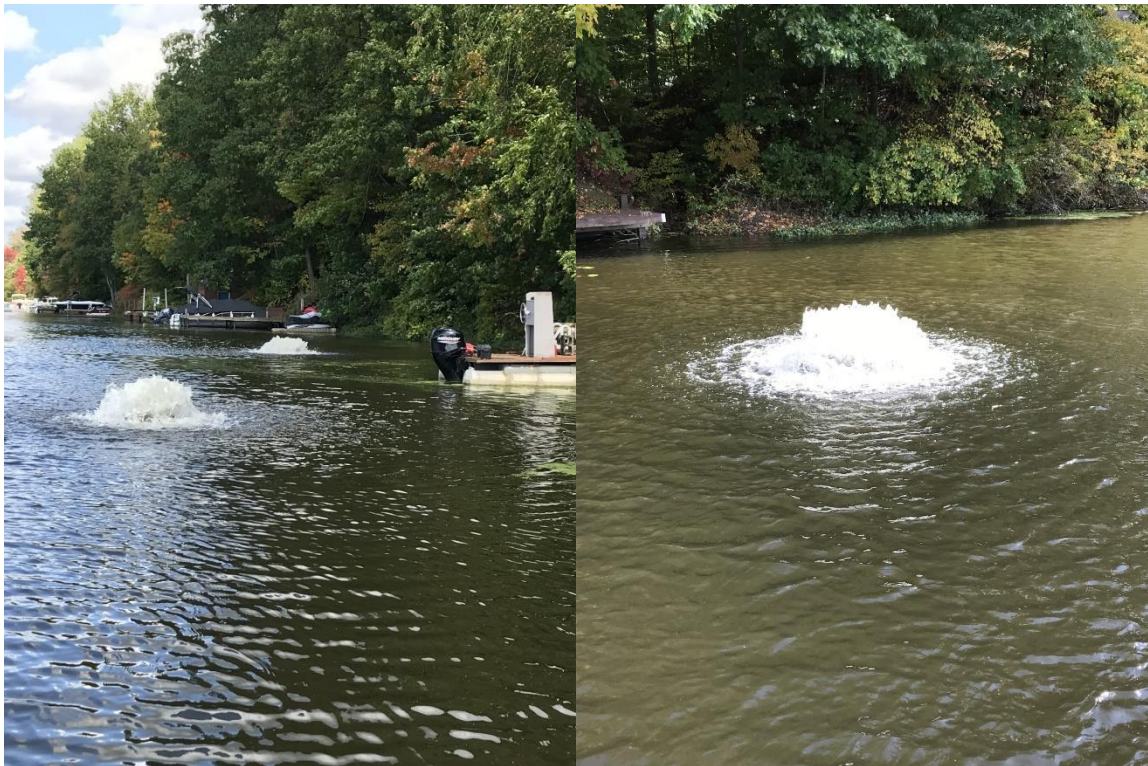
Figures 33 and 34: Surface aerators being utilized at the inlet of a reservoir to assist with anoxia derived from decomposition (Photos: Edward Kwietniewski).

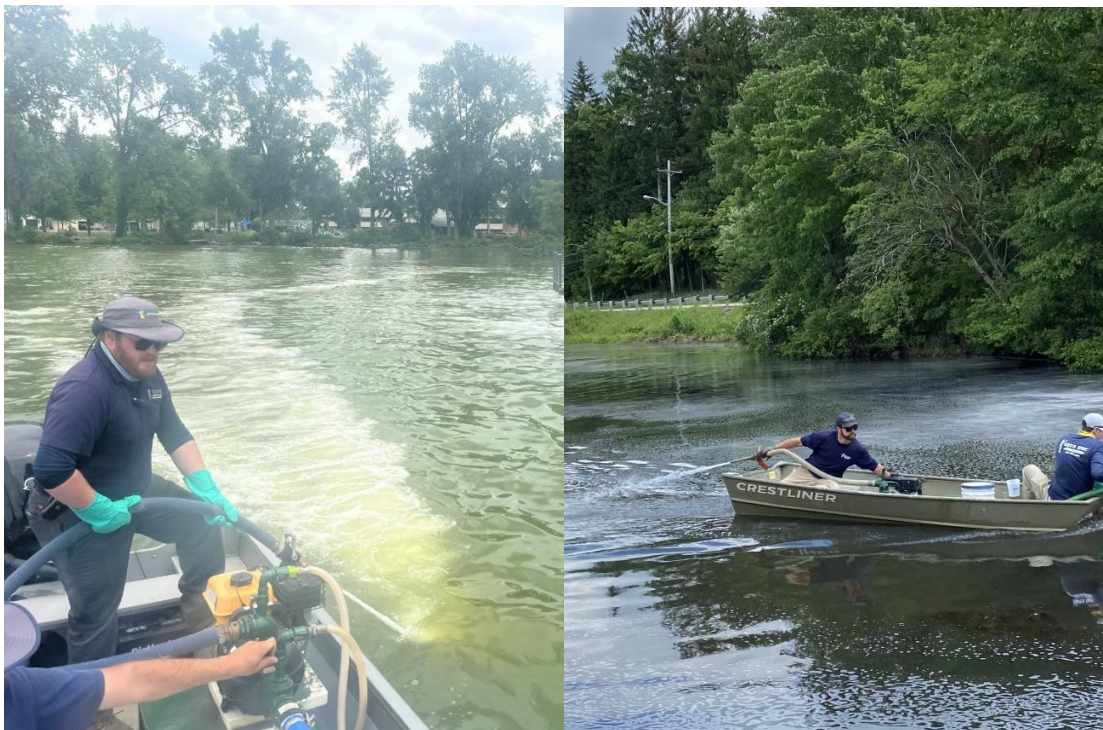
Figures 36 and 37: Pictures of algaecide/herbicide applications being conducted with different equipment types (Photo: Edward Kwietniewski).

**Figures 36 and 37:** Pictures of algaecide/herbicide applications being conducted with different equipment types (Photo: Edward Kwietniewski).

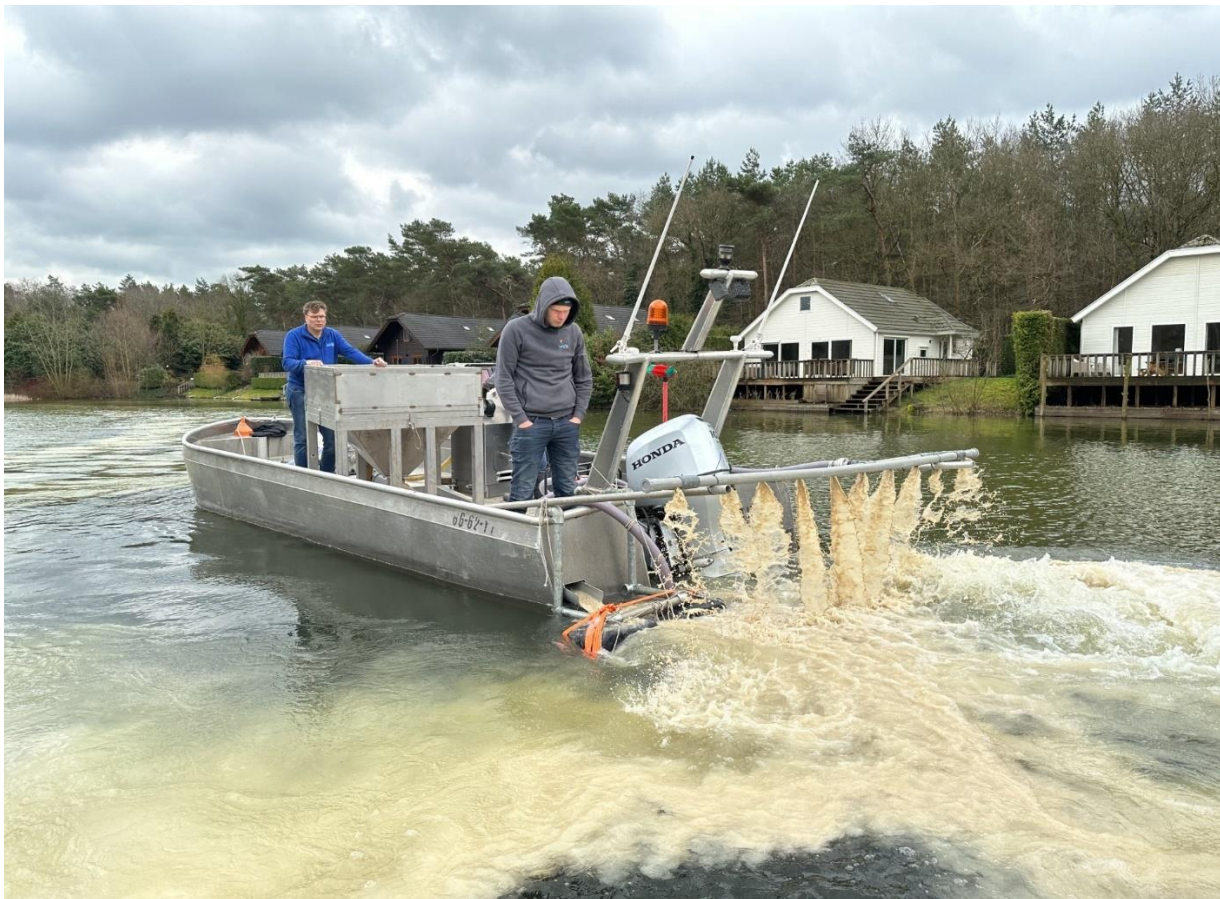
Figure 38: A Phoslock application showing the cloud of precipitant and the specialized equipment commonly used (Photo credit: Derek Johnson).

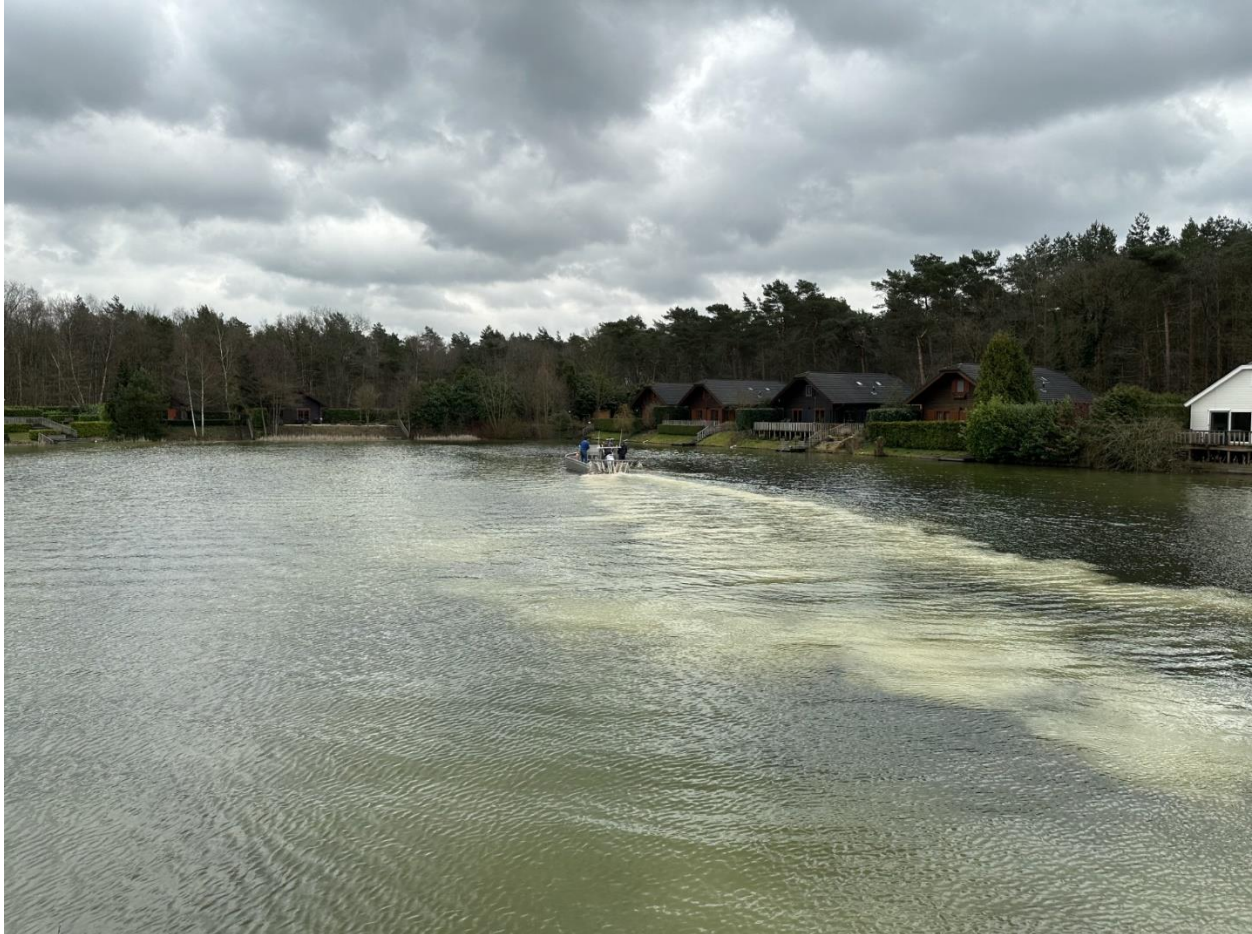
Figure 39: A Phoslock application showing the cloud of precipitant suspended behind the application boat (Photo credit: Derek Johnson).

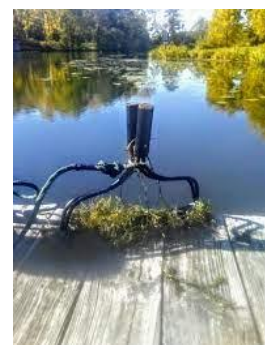
Aquatic plant sampling with a “macrophyte rake”

Depth and sediment depth with a sediment probe

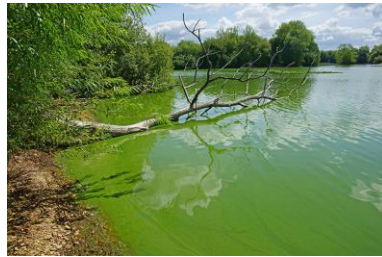
Neon-green “paint-like” spatter

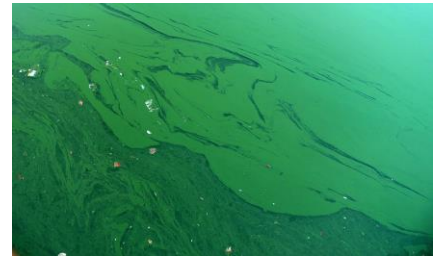
Odd smell from geosmin release

“Blue-green” color

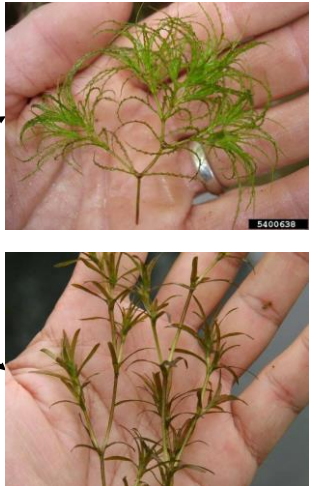
- **Brittle naiad** (*Najas minor*)
- Slender naiad (*Najas flexilis*)
